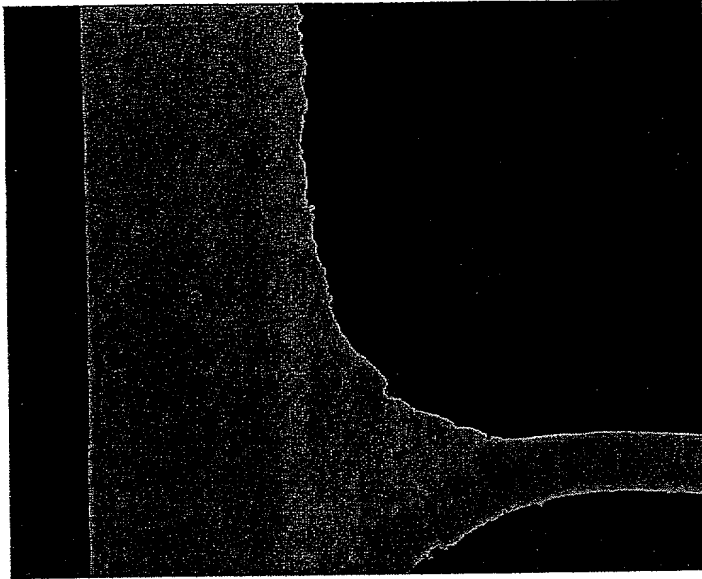
Fig. 3

Figure 3: Braze Joints of Ni/Cu/SS, Brazing Temperature 1200°C

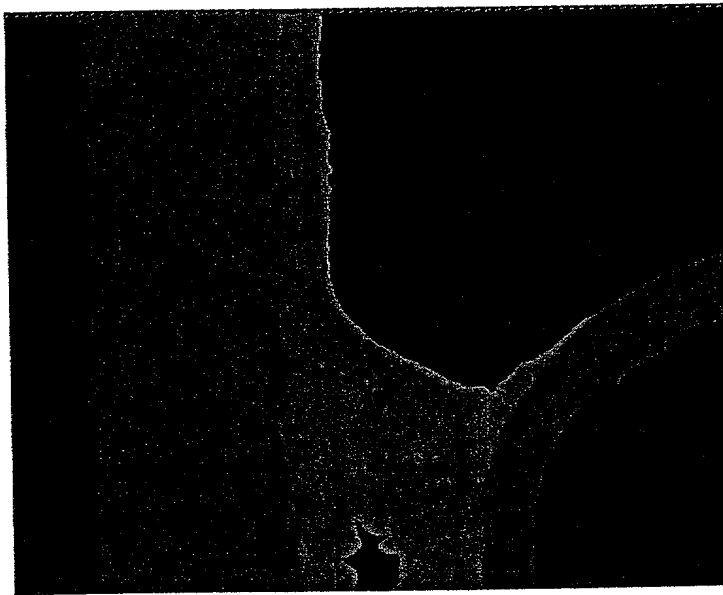
Fig. 4

Figure 4: Braze Joints of Ni/Cu/SS, Brazing Temperature 1130°C. The void is due to incomplete melting of Ni layer.

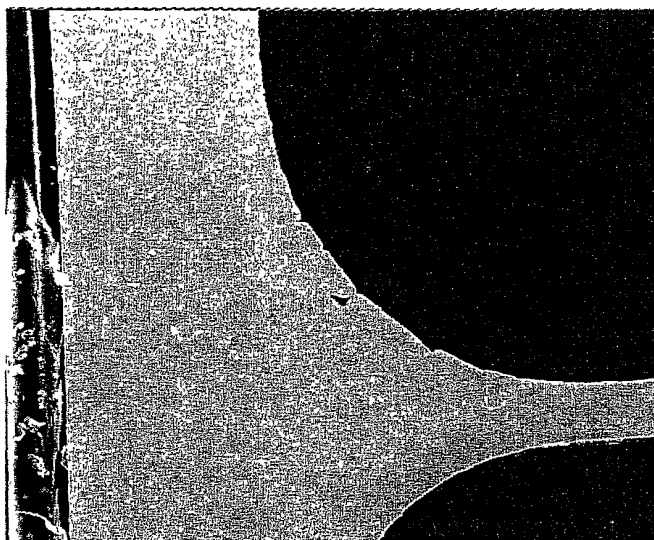
Fig. 5

Figure 5: Braze Joints of Cu/Ni/SS, Brazing Temperature 1130°C

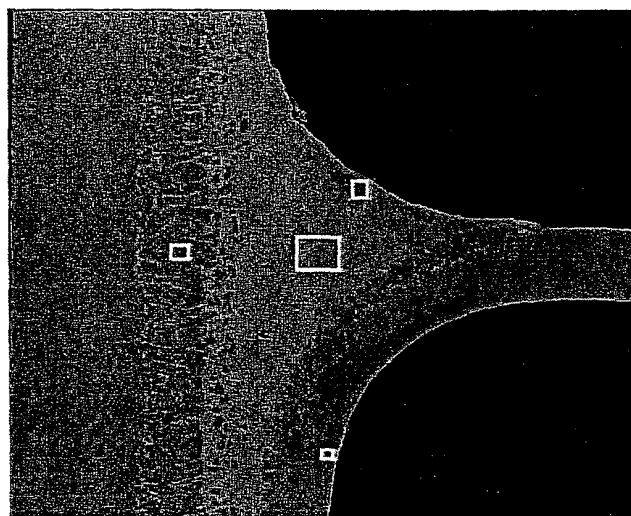
Fig. 6

Figure 6: Braze joint of 50Cu/25Al/SS/25Al/50Cu, Brazing Temperature 1130°C
